Locating DNAPLs in Hard Rock at Former MGP Site

GeoTrax Survey™ Case Study (Page 1 of 3)

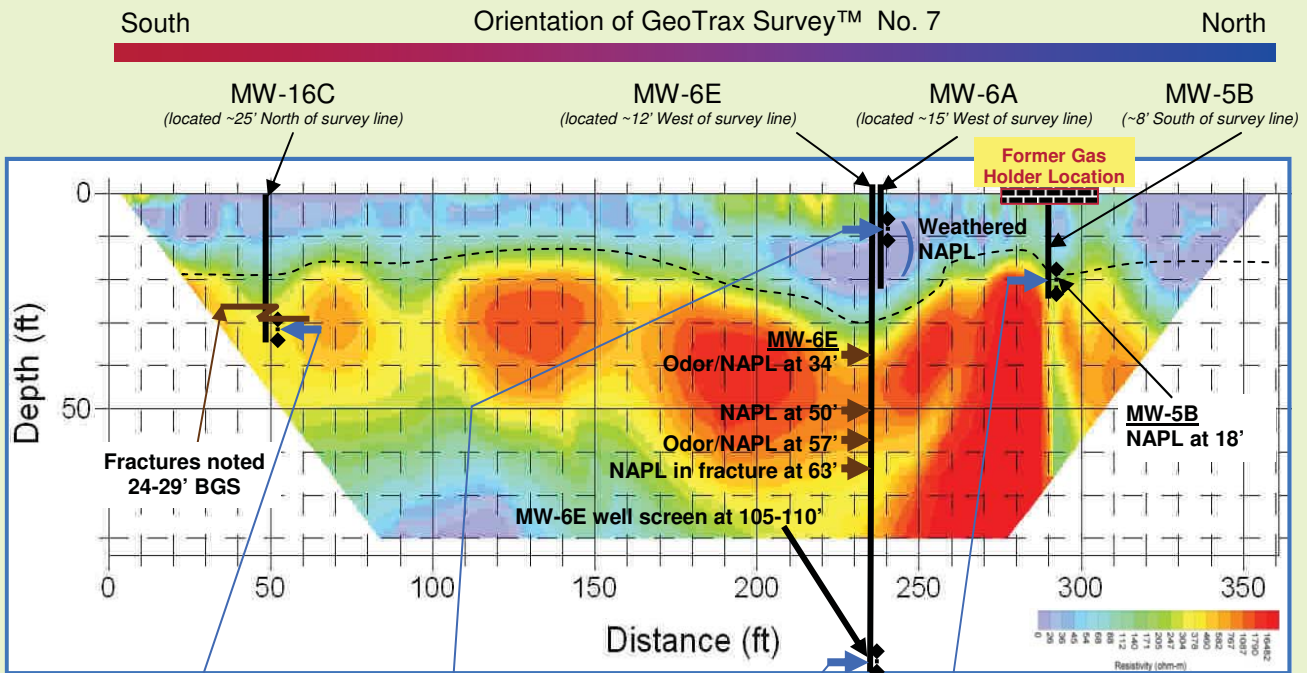
MW-16C	
Sample Date	9/06
Units	µg/L
Benzene	180
Toluene	<40
Ethylbenzene	470
Xylene	320
Total PAH	3,688
Benzo(a)Pyrene	12

MW-6A	
VOCs in Groundwater (ug/L)	
Sample Date	9/1/2004
MTBE	<20
Benzene	3,500
Toluene	1,400
Ethylbenzene	3400
Total Xylenes	4900
1,2 - Dichloroethane	62
Total Naphthalene	5600

MW-6E	
VOCs in Groundwater (ug/L)	
Sample Date	9/1/2004
MTBE	<0.30
Benzene	0.45
Toluene	<0.40
Ethylbenzene	<0.30
Total Xylenes	<0.70
1,2 - Dichloroethane	<0.40
Total Naphthalene	0.73

MW-5B	
VOCs in Groundwater (ug/L)	
Sample Date	11/11/2003
MTBE	<20
Benzene	31,000
Toluene	11,000
Ethylbenzene	3300
Total Xylenes	3600
1,2 - Dichloroethane	<15
Total Naphthalene	8900

- Survey image generally shows difference in alluvial geology in upper ~20 feet with more conductive silts/clays (light blue zones) versus underlying fractured dolomite rock with higher resistivities (green-yellow zones)

- Image shows anomalous zones especially below the former gas holder location where a strong vertical resistive signature indicates likely presence of DNAPL contamination (red zones); DNAPL confirmed at this location by borehole for monitoring well MW-5B

- DNAPL contamination confirmed in borehole for MW-6E in zones coincident with higher resistivity (i.e., red/orange zones)
- Image implies that resistive zones extend below the bottom of the image; Monitoring well MW-6E confirms presence of groundwater contamination at 105-110 feet BGS.

- Highly conductive anomaly coincident with noted presence of weathered NAPL in alluvium soil boring (purple zone at borehole for monitoring well MW-6A)
