Locating Extent of Landfill and Leachate

GeoTrax Survey™ Case Study

Located Extent of Pre Subtitle-D Landfill And Cave Filled with Leachate Impacted Groundwater

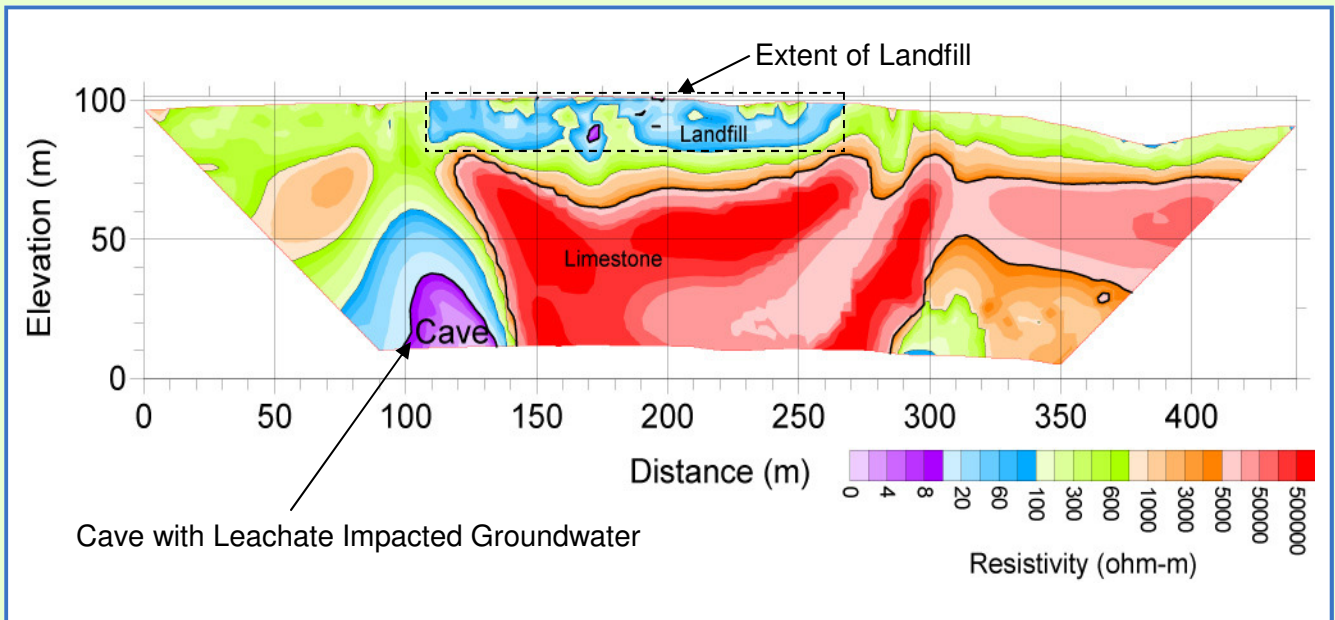
- The landfill can be seen clearly in the upper central portion of the image and generally has a low resistivity. The very resistive red portion of the image appears to be relatively competent limestone of the Boone Formation.

- Due to the geometry and the low resistivity (i.e. high conductivity) of the anomaly in the lower left of the image, it appears to Aestus that there is a cave present which is filled with a conductive material; most likely leachate impacted groundwater.
